**CITY OF SAN DIEGO  
M E M O R A N D U M  
As-Graded Review**

SUBJECT: Fairmount Avenue and Aldine Drive Slope and Drainage

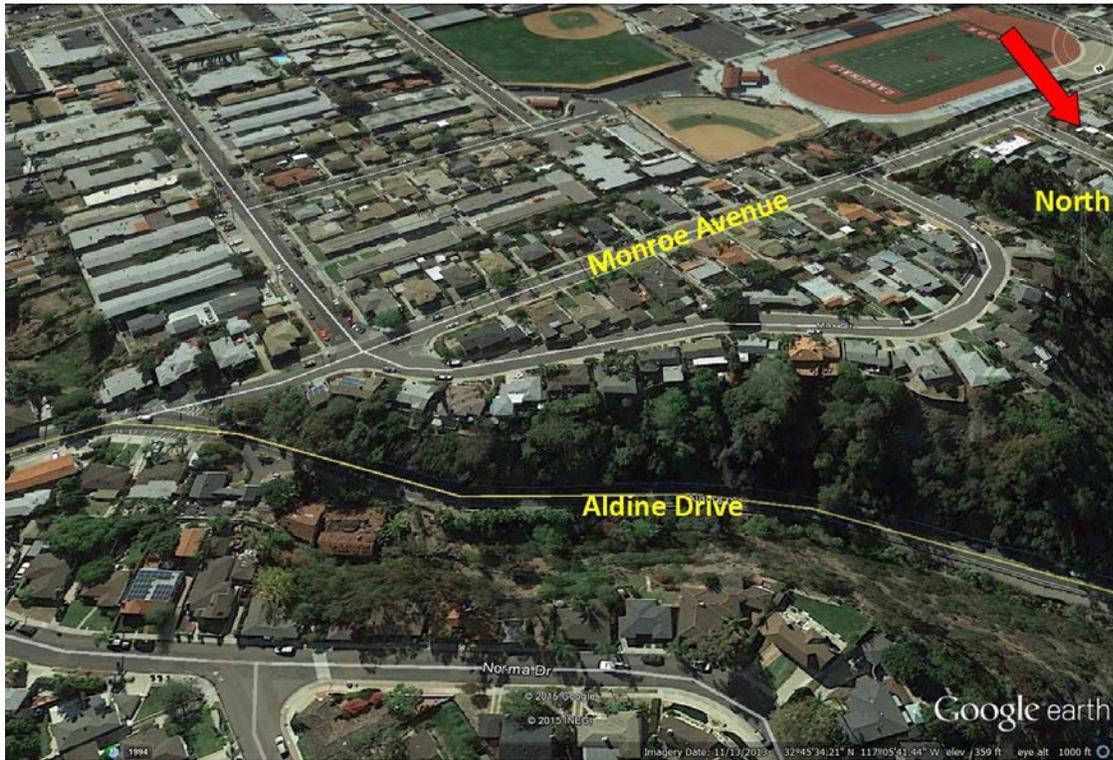
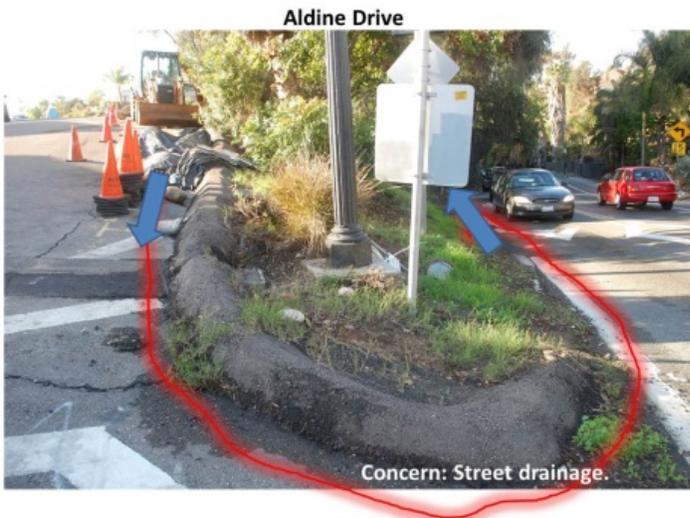
**Aldine Drive:**

We began our tour of the affected areas at the intersection of Monroe Avenue and Aldine Drive. The drainage of the intersection is controlled by formed asphalt curbs which are reportedly overtopped during heavy rain, especially near the intersection. Continuing down Aldine toward Fairmount, Mr. Moty pointed out that cobbles and debris eroded from the slope on the uphill side roll into the travelway and can at times block the drainage and force water, rocks and soil into the lane, creating

traffic impediments. In addition, some of the drainage facilities, specifically inlets, are in need of maintenance, repair and/or replacement.

Aldine Drive: The drainage in the Right of Way should be improved by the City to accept the water runoff from the slope and adjacent streets without overtopping existing curbs. The erosion of soil and rock from the slope onto the street must be addressed by the City. These conditions should be referred to the City's Transportation and Stormwater Department for review and design.

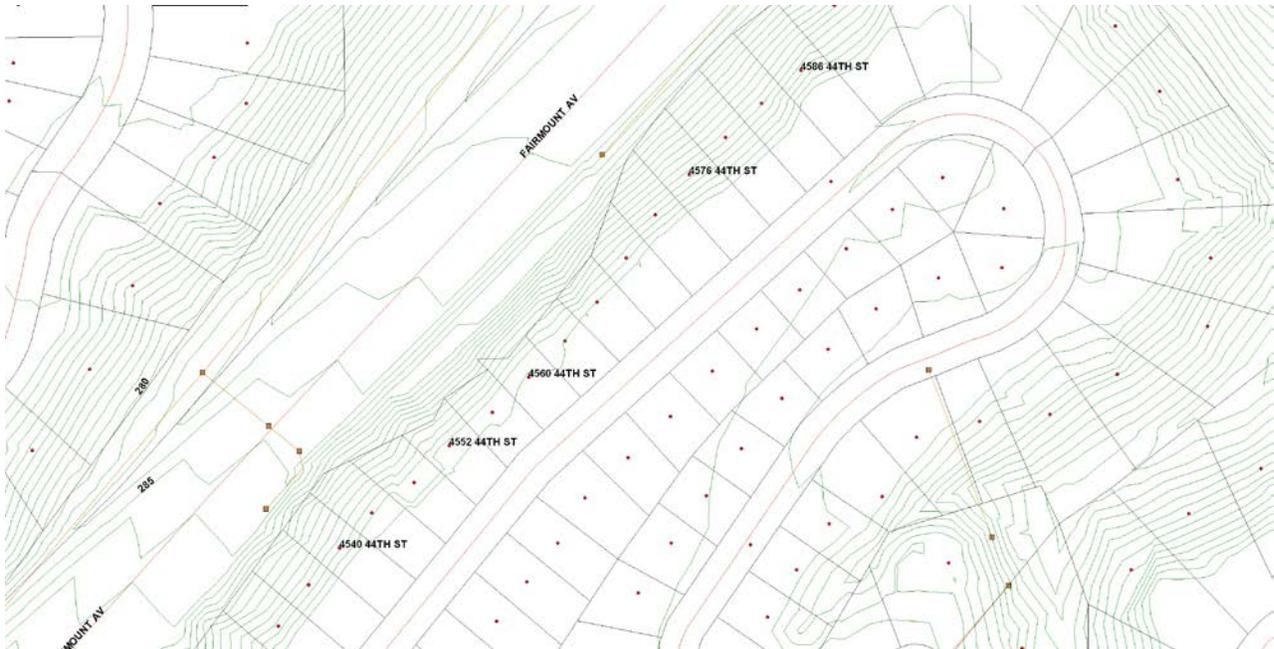
It was noted that most or all of the lots drain to the rear of the property over the slope rather than to 44<sup>th</sup> street, including drainage from the house roofs. Lot and roof drainage was directed to the rear yard and over the slope rather than to 44<sup>th</sup> Street, which was not standard at the time and may have been changed since development occurred.

The majority of the site drainage from the properties on 44<sup>th</sup> Street drain to the rear of the properties and over the slope toward Fairmount Avenue. This practice exacerbates the natural erosive condition of the slope from ordinary rainfall. All roof drainage, and as much lot drainage as practicable, should be captured and redirected to the street. Water that falls on the slope should be collected, if possible, and piped down the slope into drainage improvements at the bottom along Fairmount. The encroachment for private drains by property owners into the Fairmount right-of-way will require a permit from the City, but would slow erosion of the slope. In addition, a landscape architect should be consulted to recommend plantings that would anchor the soil in place. One homeowner showed that his drainage had been collected and discharged through the sidewalk, but stated that during street renovation his sidewalk was replaced, but not the drain, blocking his conduit. The drainage from the property to the street should be restored by the property owner in accordance with City standards.

Fairmount Avenue: All drainage from runoff on private property should be collected and redirected away from the slope where possible, either onto 44<sup>th</sup> street or into a drain system and conveyed to Fairmount Avenue to an approved drainage facility. This will require an encroachment permit into the right-of-way by the property owners. Guttering should be installed to collect roof runoff and convey it to the street. Irrigation of slopes should be minimal and only sufficient to maintain vegetation cover. The slopes should be landscaped with drought-tolerant, deep-rooted shrubs as recommended by a landscape architect to improve surficial slope stability by anchoring surface soil.
