September 4, 2020

**Re: Tree maintenance in public right of way; community of Kensington**

### 4190 Monroe Avenue Tree Removal

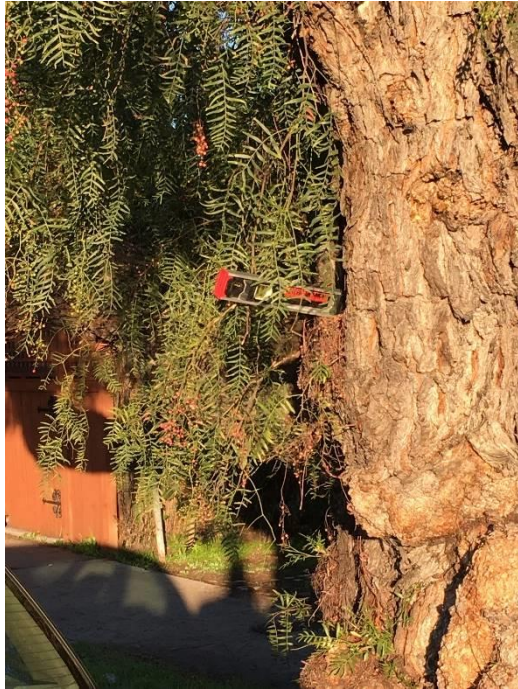
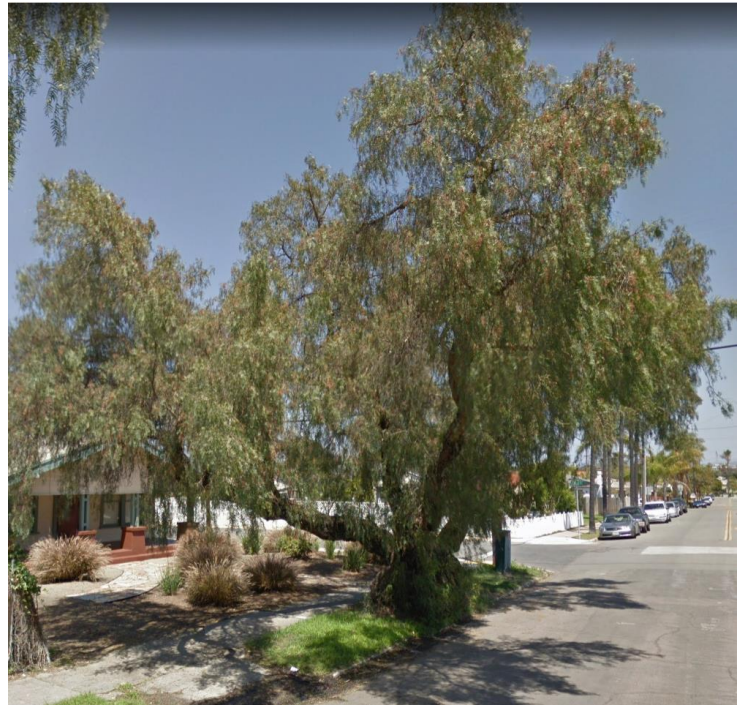
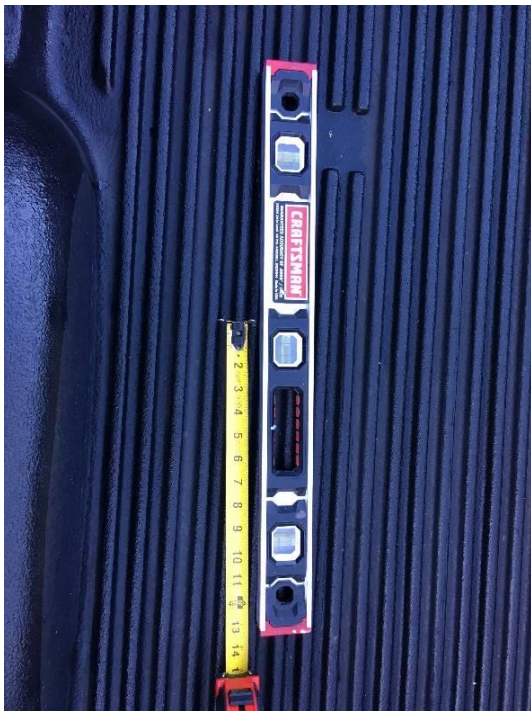
- 13 inch deep pocket of decay was found in one of the main stems. The other stems of tree all had significant amounts of decay.

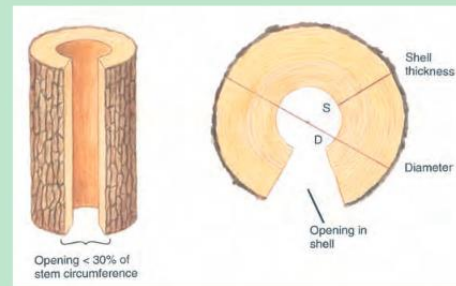
Figure 3.30. There needs to be at least 2 inches of sound wood in the shell for each 6 inches of diameter when openings occur in the stem. The openings must be smaller than 30% of the stem circumference.
