**CITY OF SAN DIEGO  
M E M O R A N D U M  
As-Graded Review**

SUBJECT: Fairmount Avenue and Aldine Drive Slope and Drainage

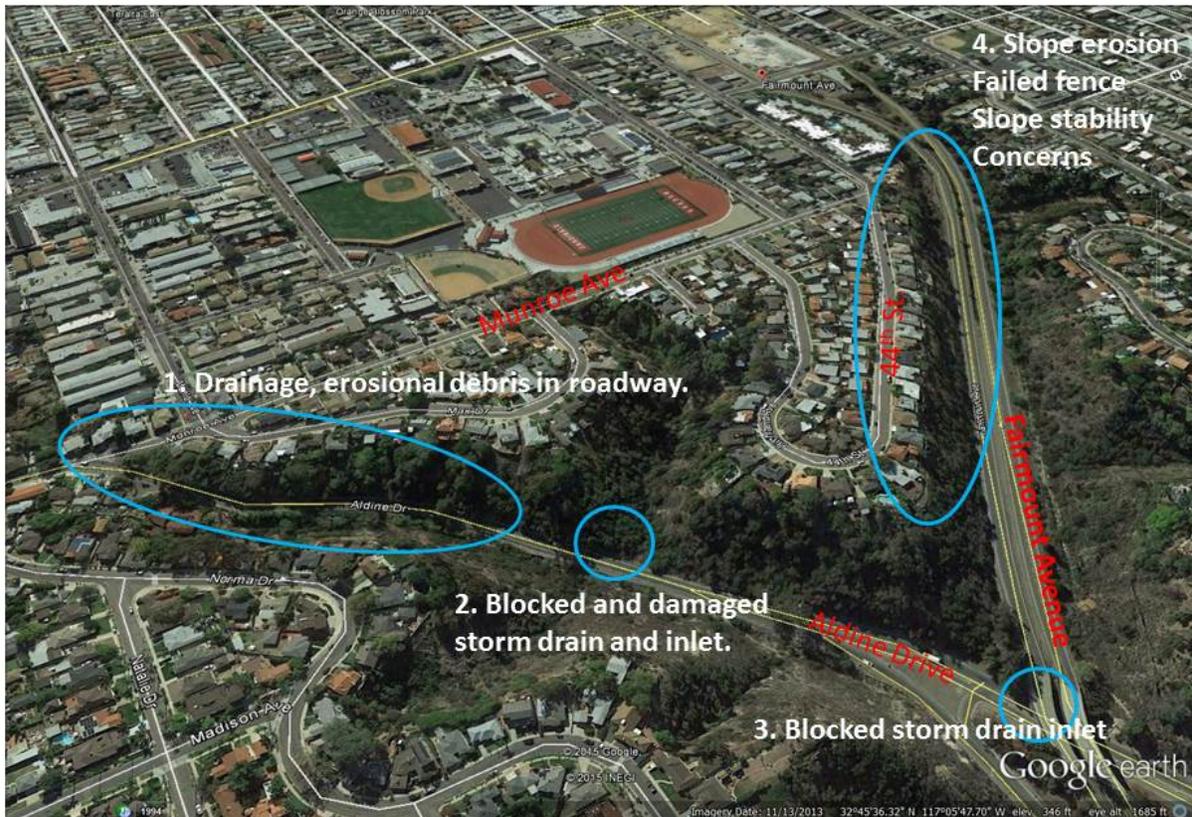
**Subject Areas on Fairmount Avenue and Aldine Drive**

On Wednesday, December 17, 2014, I met with David Moty, Chair of the Kensington Talmadge Planning Group, and Ralph Dimarucut, City Council District 9 Staff to view areas of Aldine Drive and Fairmount Avenue of concern to their constituency. Please refer to the photo below for the discussion of areas visited and observed.

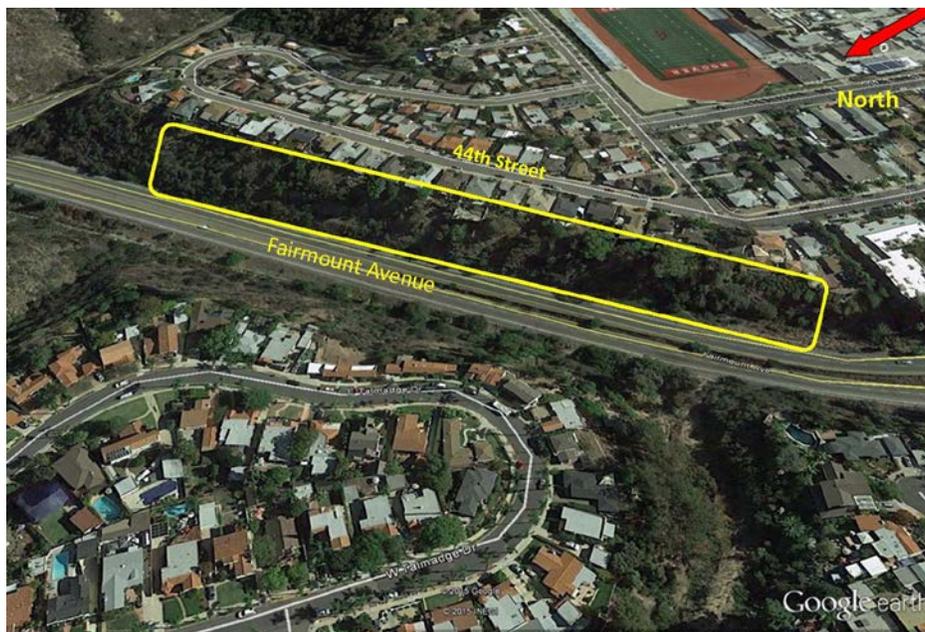
was visited or viewed from the neighboring property. The constituents expressed concern regarding the stability of the slope and the effect of the portion of the slope that formed the City Right-of-Way for Fairmount. Plans for the homes and

**Slopes:** The slope behind the homes was originally steep, consistent with natural slopes in the area which range from 30 to 35 degrees. Cut slopes were created in the Fairmount right-of-way at an angle much steeper than allowed under today's standards, but typical for development of the period from the 1940's to the 1960's. The lower slope on what is described as the City easement appears to be cut steeper than the rear yard slope, and is reportedly delineated by a chain link fence that was erected along the rear of the homes approximately midway up the slope. The fence was badly deteriorated, and had fallen over or been undermined along most of the alignment.

The slope appears to be grossly stable and no discernible indications of deep seated instability or landslides were observed. However, surficial stability and erosion appear to be problematic and significant evidence of shallow surface failures and erosion on the private property was observed on several properties. Erosion is a function of gravity, slope angle, types of earth materials, types and density of vegetation, and critically, water saturation and drainage.

The current fence has failed and should be removed. Replacement of the fence is at the discretion of the Transportation and Stormwater Department. It is unclear whether or not a fence is required as a barrier between Fairmount Avenue and the private property. The fence provides no positive or negative benefit with respect to slope stability.
